## Marine Engineers and Environmental Consultants

March 6, 2023

Subject: Hurricane Ian Retaining Wall Impacts Assessment

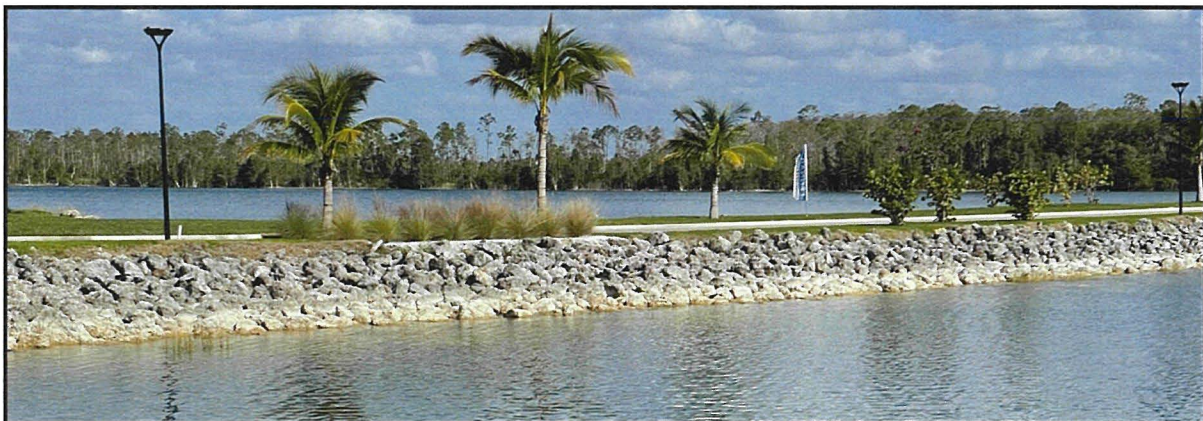
For the south lake, the north shoreline is revetted with limestone boulders, which make it an articulating structure. As the wave energy reached the revetment the energy is dispersed omni-directional and the boulders shift or move as they absorb the waves. There did not appear to be any voids or significant shifts in the boulders. This is in part because the rock sizes are appropriate for this level of wave energy.

***This is a view of the riprap revetment along the causeway between the north and south lakes. Note that there are no voids or open areas indicating a shift from the incoming wave action, demonstrating the effectiveness of a revetment in attenuating waves.***

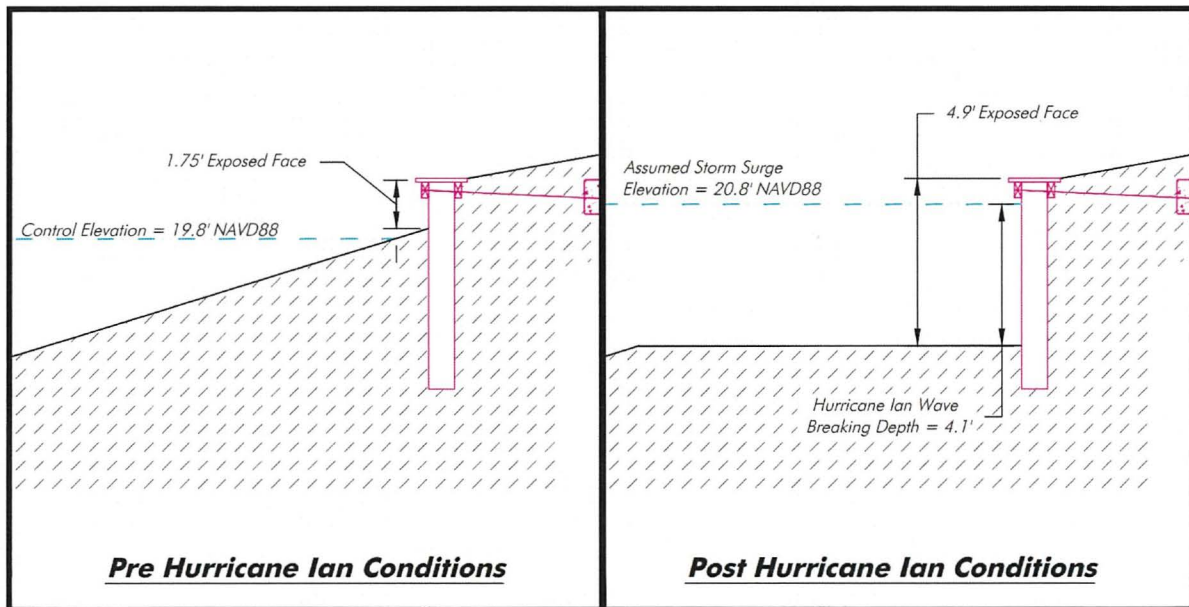
Additional scour at the toe was directly related to the elevation of the lake at the north end during the hurricane. We assumed that the lake was at the control elevation. However, there is also a storm surge component that was likely a contributing factor to failure of the seawall. The movement of the water across the surface of the lake for an extended duration essentially created a storm surge, captured by the north end of the lake, artificially increasing the elevation of the incoming waves, and potentially overtopping the retaining wall. A higher water elevation as show below would reduce the amount of scour at the base of the seawall but would overtop the wall with more consistency, adding an additional hydrostatic surcharge that would be significant once the wind speeds reduced or changed direction, significantly increasing the active earth loads on the retaining wall without having in passive earth pressures in front of the retaining wall as a result of the loss of the littoral shelf.

Because the slope of the littoral shelf is unprotected, any scour occurring will increase the depth of water and increase the height of wave that can be supported at the base of the structure. Consideration should be given to the fact that over the six hours of recorded wind speeds there was likely little in way of a protective shelf left in front of the retaining wall.

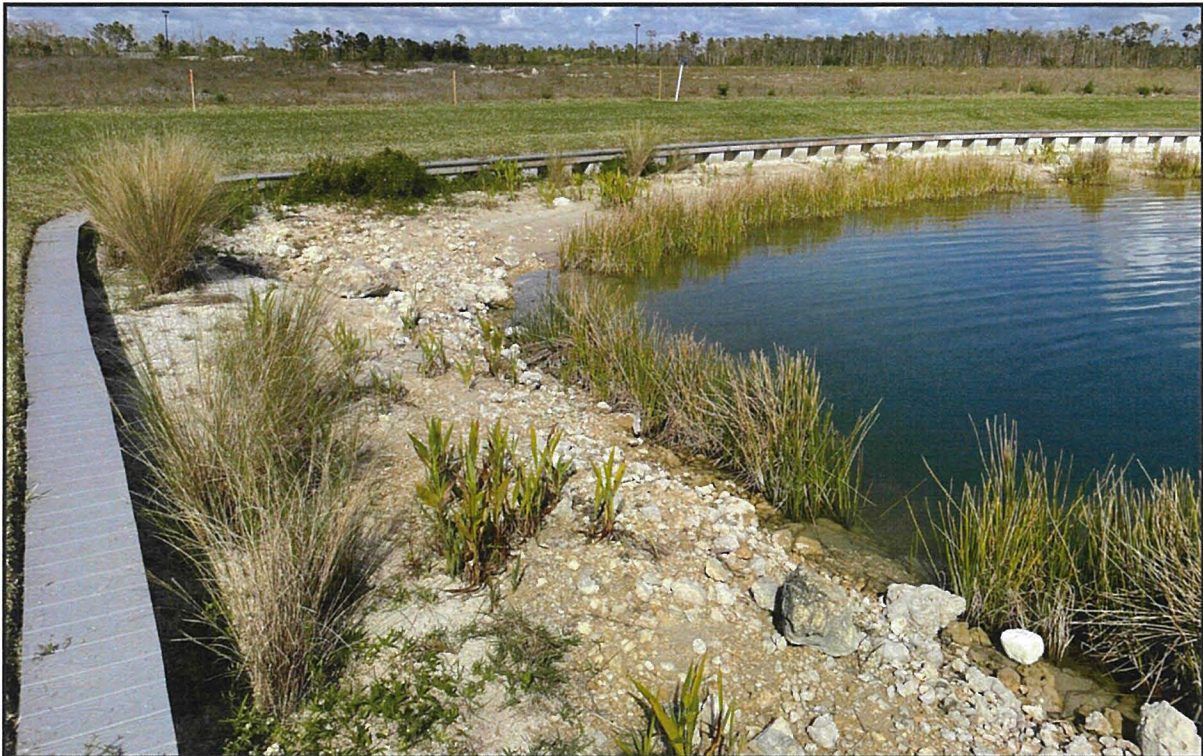
There are basically four conditions associated with the retaining wall. The first was the intended design condition. This consisted of the retaining wall at the base of the sloped berm constituting the perimeter of the stormwater management system. In front was a planted littoral shelf with a substrate consisting of sand, clay, and a variety of rock sizes. Below is a photo of the intended design. Note that the expose face, or the distance from the top of the retaining wall cap to the substrate on the waterward side, was minimal and consistent with the maximum of 1.75' allowed in the construction drawings.

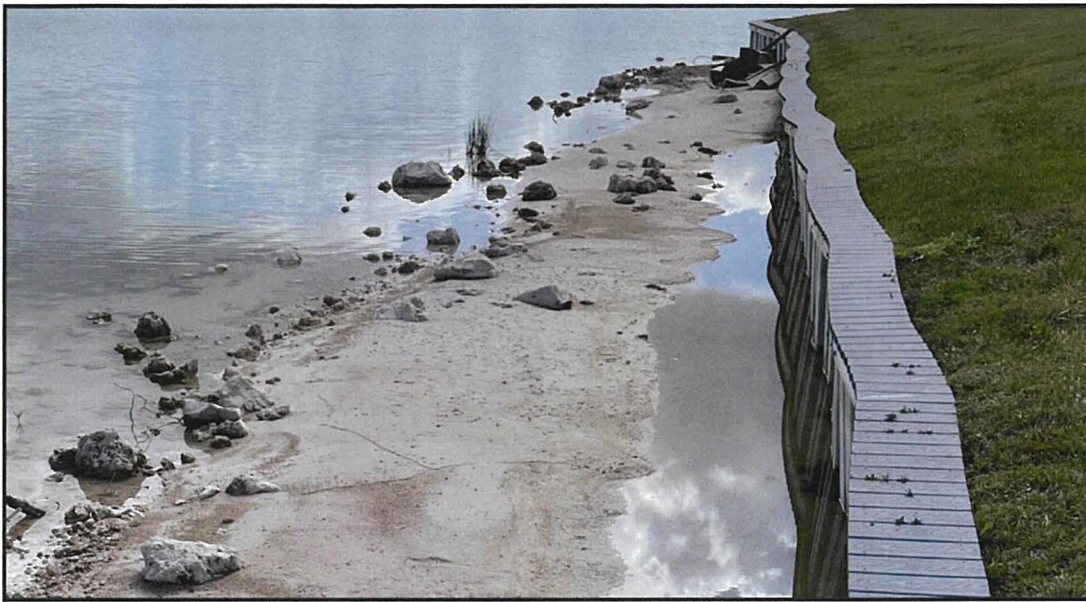
As the profile in front of the seawall was lowered we observed failures in many different forms. Generally as the profile of the shoreline decreased or flattened, and the exposed face increased, the active load (landward side) on the wall increased. Generally when the exposed face reached 2.4' the deadmen held tight but the wall between the deadmen, set 12' on center, started to bow out. This can be seen as a scalloping of the top of the seawall cap. In the photo below, note the flat profile of the littoral shelf and water abutting the toe of the seawall panel. There is very little vegetation remaining at the base of the retaining wall and in this case the wall, depending on the control elevation of the lake, is now functioning as a seawall.

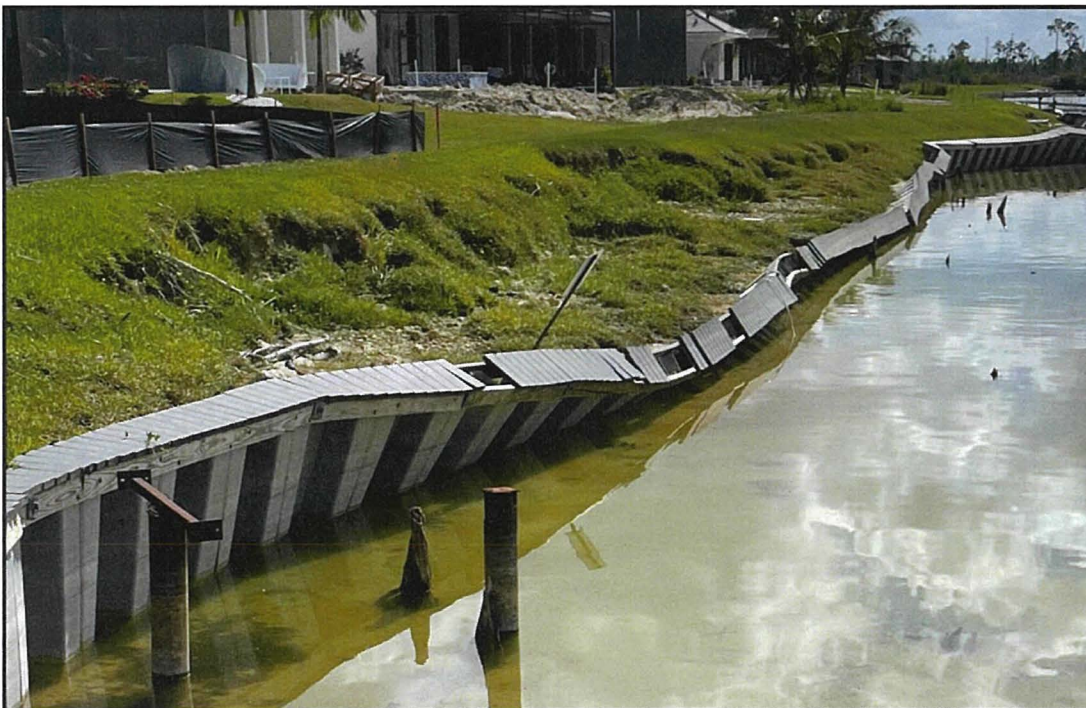
The next form of failure was loss of the deadmen. In the photo below the deadmen anchoring the retaining wall failed. It is likely that the saturated soil condition, either from rain fall, inundation from wave overtopping or both, eliminated the holding power of the soil in front of the face of the deadman, allowing them to move in the waterward direction. This then allowed the retaining wall to fall over rotating about the toe or bottom of the panels. There was not sufficient soil on the passive (waterward) side to counter the loss of the anchors. This was the most common failure mode. The areas that exhibited the most destruction were at the north end directly fronting the open waters of the lake. In some instances, particularly with the failure shown below, there was overtopping of the stormwater berm from the land side and discharge to the backside of the retaining wall, further saturating the soil and reducing the effectiveness of the dead men.

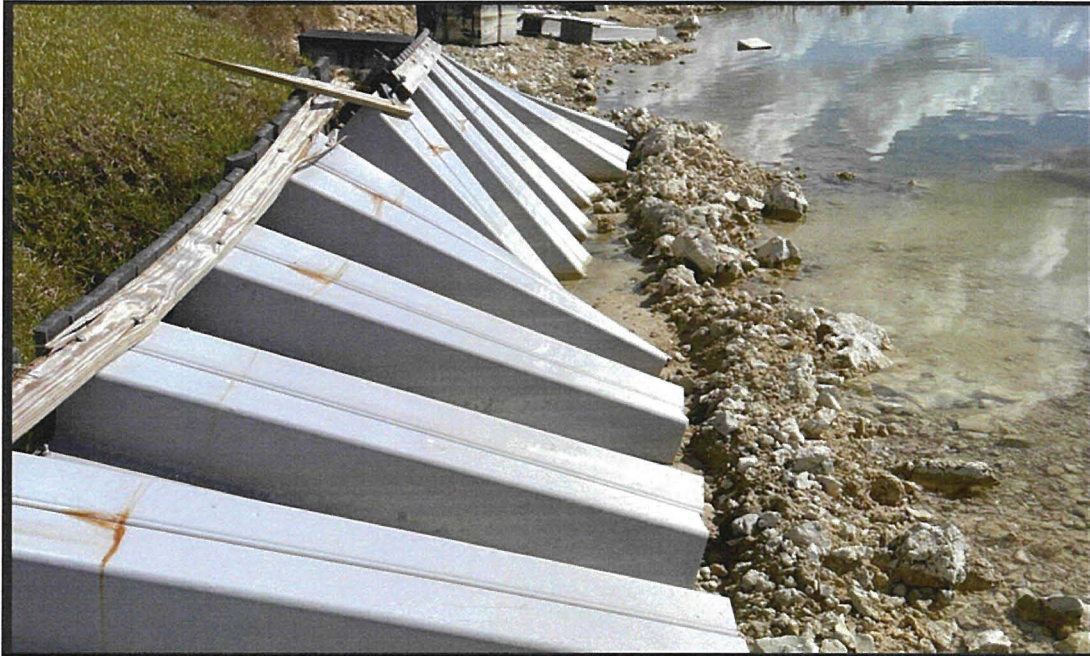
The next form of failure, as shown in the following photo, is where the scour at the toe of the retaining wall eliminated the littoral shelf and lowered the profile to the point that the toe of the wall kicked out. Note that the tie-backs and deadmen are still in place. This form of failure was uncommon. The previous failure was the more common condition indicating that the wind induced shift of the water surface from the south to the north induced a storm surge that likely overtopped the existing retaining wall, both lowering the profile in front and saturating the soil, reducing the effectiveness of the deadmen.

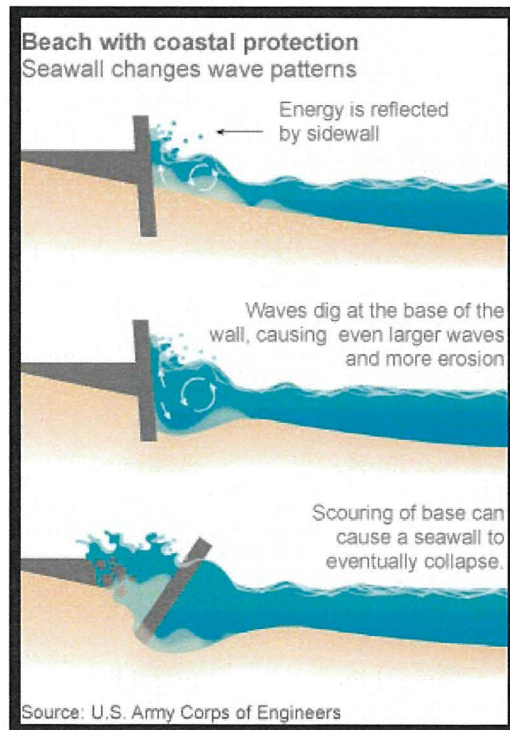
To the right is a graphic depicting a generalized erosion condition that reflects the observations on site. As the load on the wall increases, based on the scour and increased exposed face, the wall fails in two modes, both shown above. Either the deadman holds and the toe of the wall kicks out at the bottom or the deadman fails and the wall topples into the water as shown on the graphic.

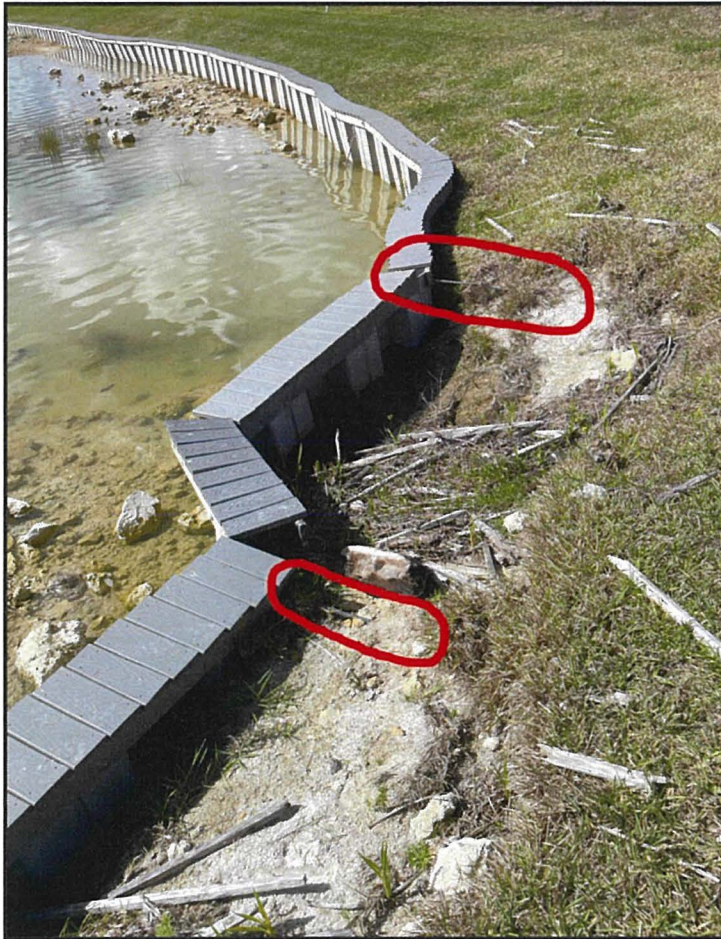
As the active load on the retaining wall decreased from erosion of the littoral shelf, the passive load increased. While the earth anchors held firm where they are attached to the cap, a noticeable bend in the cap was observed, equidistant from where the earth anchors were attached. The 2" x 6" boards provided limited resistance to the bending action, with the 2" thick section of the board providing the only resistance to the bending. This was most noticeable where the exposed face exceeded 2.4'. As the exposed face increased the curve became more pronounced and in some cases the wall failed.

*To the left is a photo of the retaining wall failure where the earth anchors and tie-backs, circled in red, held but the active load exceeded both the capacity of the seawall panel and the cap boards. Note the floating debris still remaining landward of the retaining wall, indicating that the wall was submerged at some point during the hurricane.*
