WILD BLUE LAKE RESTORATION PROJECT

**WILDBLUE
COMMUNITY
DEVELOPMENT
DISTRICT**

**MASTER PLAN WITH
KEY SHEET AND
ESTIMATED TIMELINE**

**DETAILED
LAKE BANK
RESTORATION PLAN**

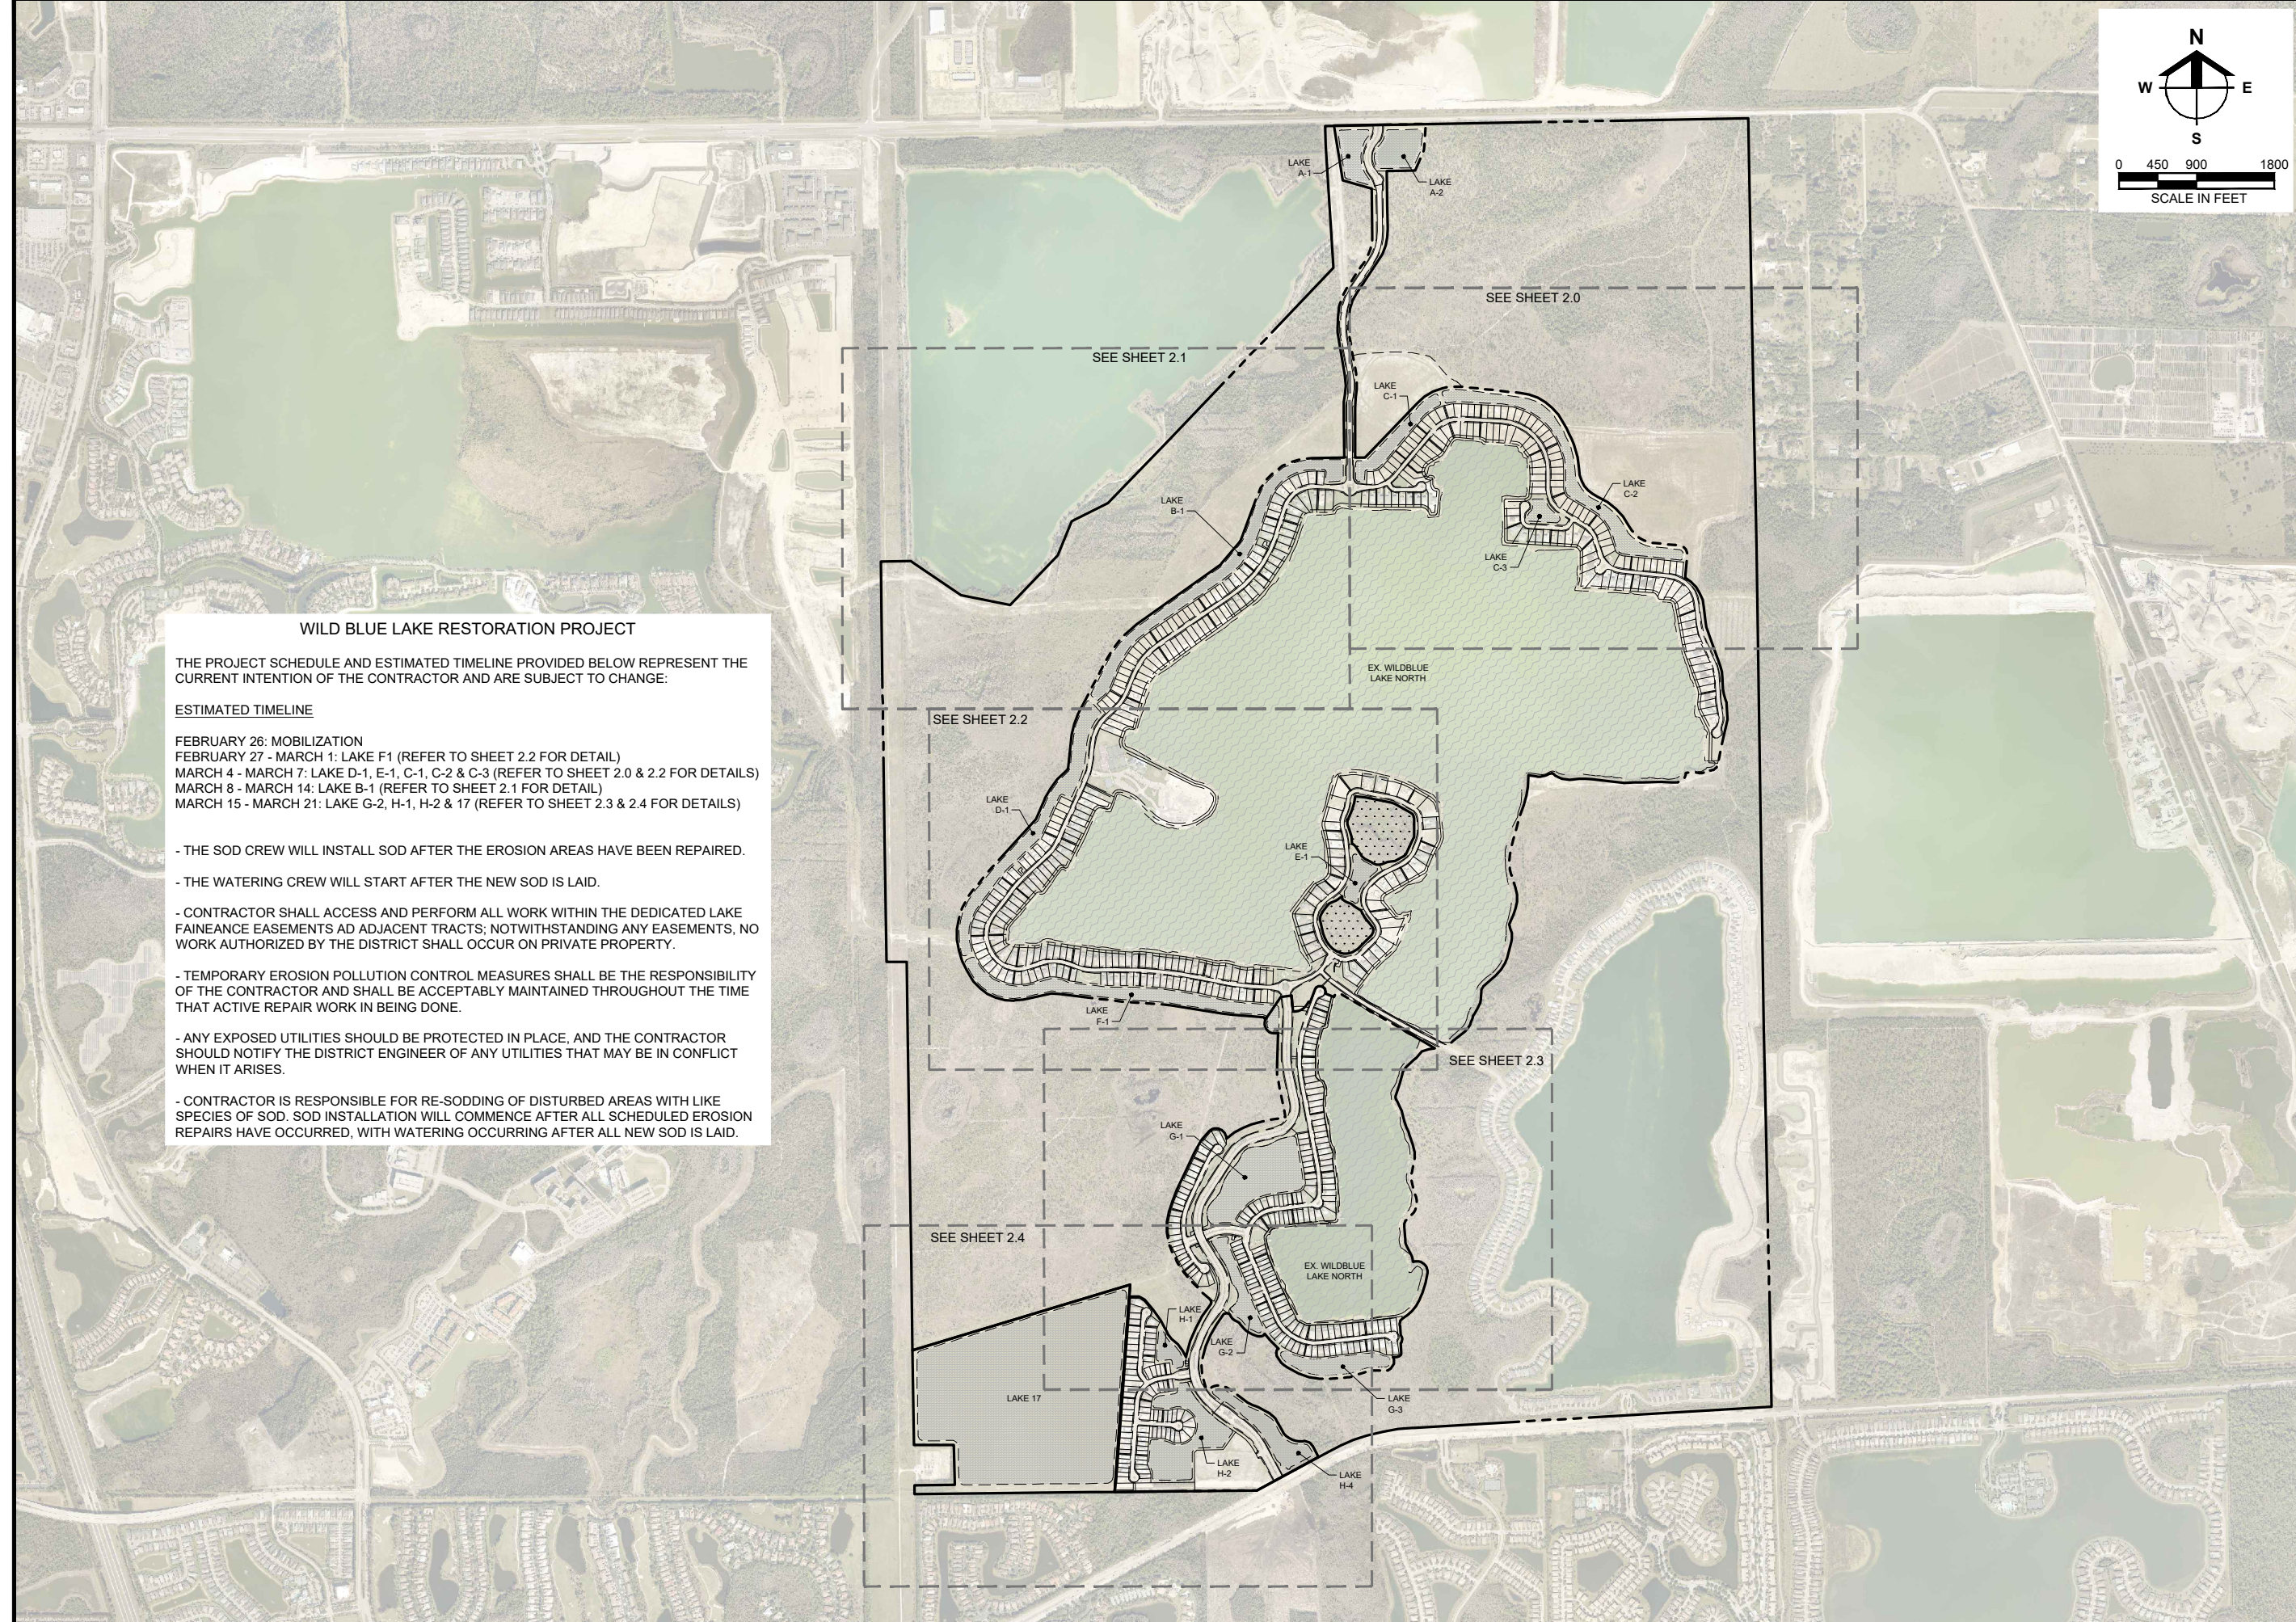
PROJECT / FILE NO.	SHEET NUMBER
23620	2.0

- FEBRUARY 26 - MOBILIZATION
- FEBRUARY 27 - MARCH 1: LAKE F1 (REFER TO SHEET 2.2 FOR DETAIL)
- MARCH 4 - MARCH 7: LAKE D-1, E-1, C-1, C-2 & C-3 (REFER TO SHEET 2.0 & 2.2 FOR DETAILS)
- MARCH 8 - MARCH 14: LAKE B-1 (REFER TO SHEET 2.1 FOR DETAIL)
- MARCH 15 - MARCH 21: LAKE G-2, H-1, H-2 & 17 (REFER TO SHEET 2.3 & 2.4 FOR DETAILS)

- THE SOD CREW WILL INSTALL SOD AFTER THE EROSION AREAS HAVE BEEN REPAIRED.
- THE WATERING CREW WILL START AFTER THE NEW SOD IS LAID.
- CONTRACTOR SHALL ACCESS AND PERFORM ALL WORK WITHIN THE DEDICATED LAKE FAINEANCE EASEMENTS AD ADJACENT TRACTS; NOTWITHSTANDING ANY EASEMENTS, NO WORK AUTHORIZED BY THE DISTRICT SHALL OCCUR ON PRIVATE PROPERTY.

- CONTRACTOR IS RESPONSIBLE FOR RE-SODDING OF DISTURBED AREAS WITH LIKE SPECIES OF SOD. SOD INSTALLATION WILL COMMENCE AFTER ALL SCHEDULED EROSION REPAIRS HAVE OCCURRED, WITH WATERING OCCURRING AFTER ALL NEW SOD IS LAID.

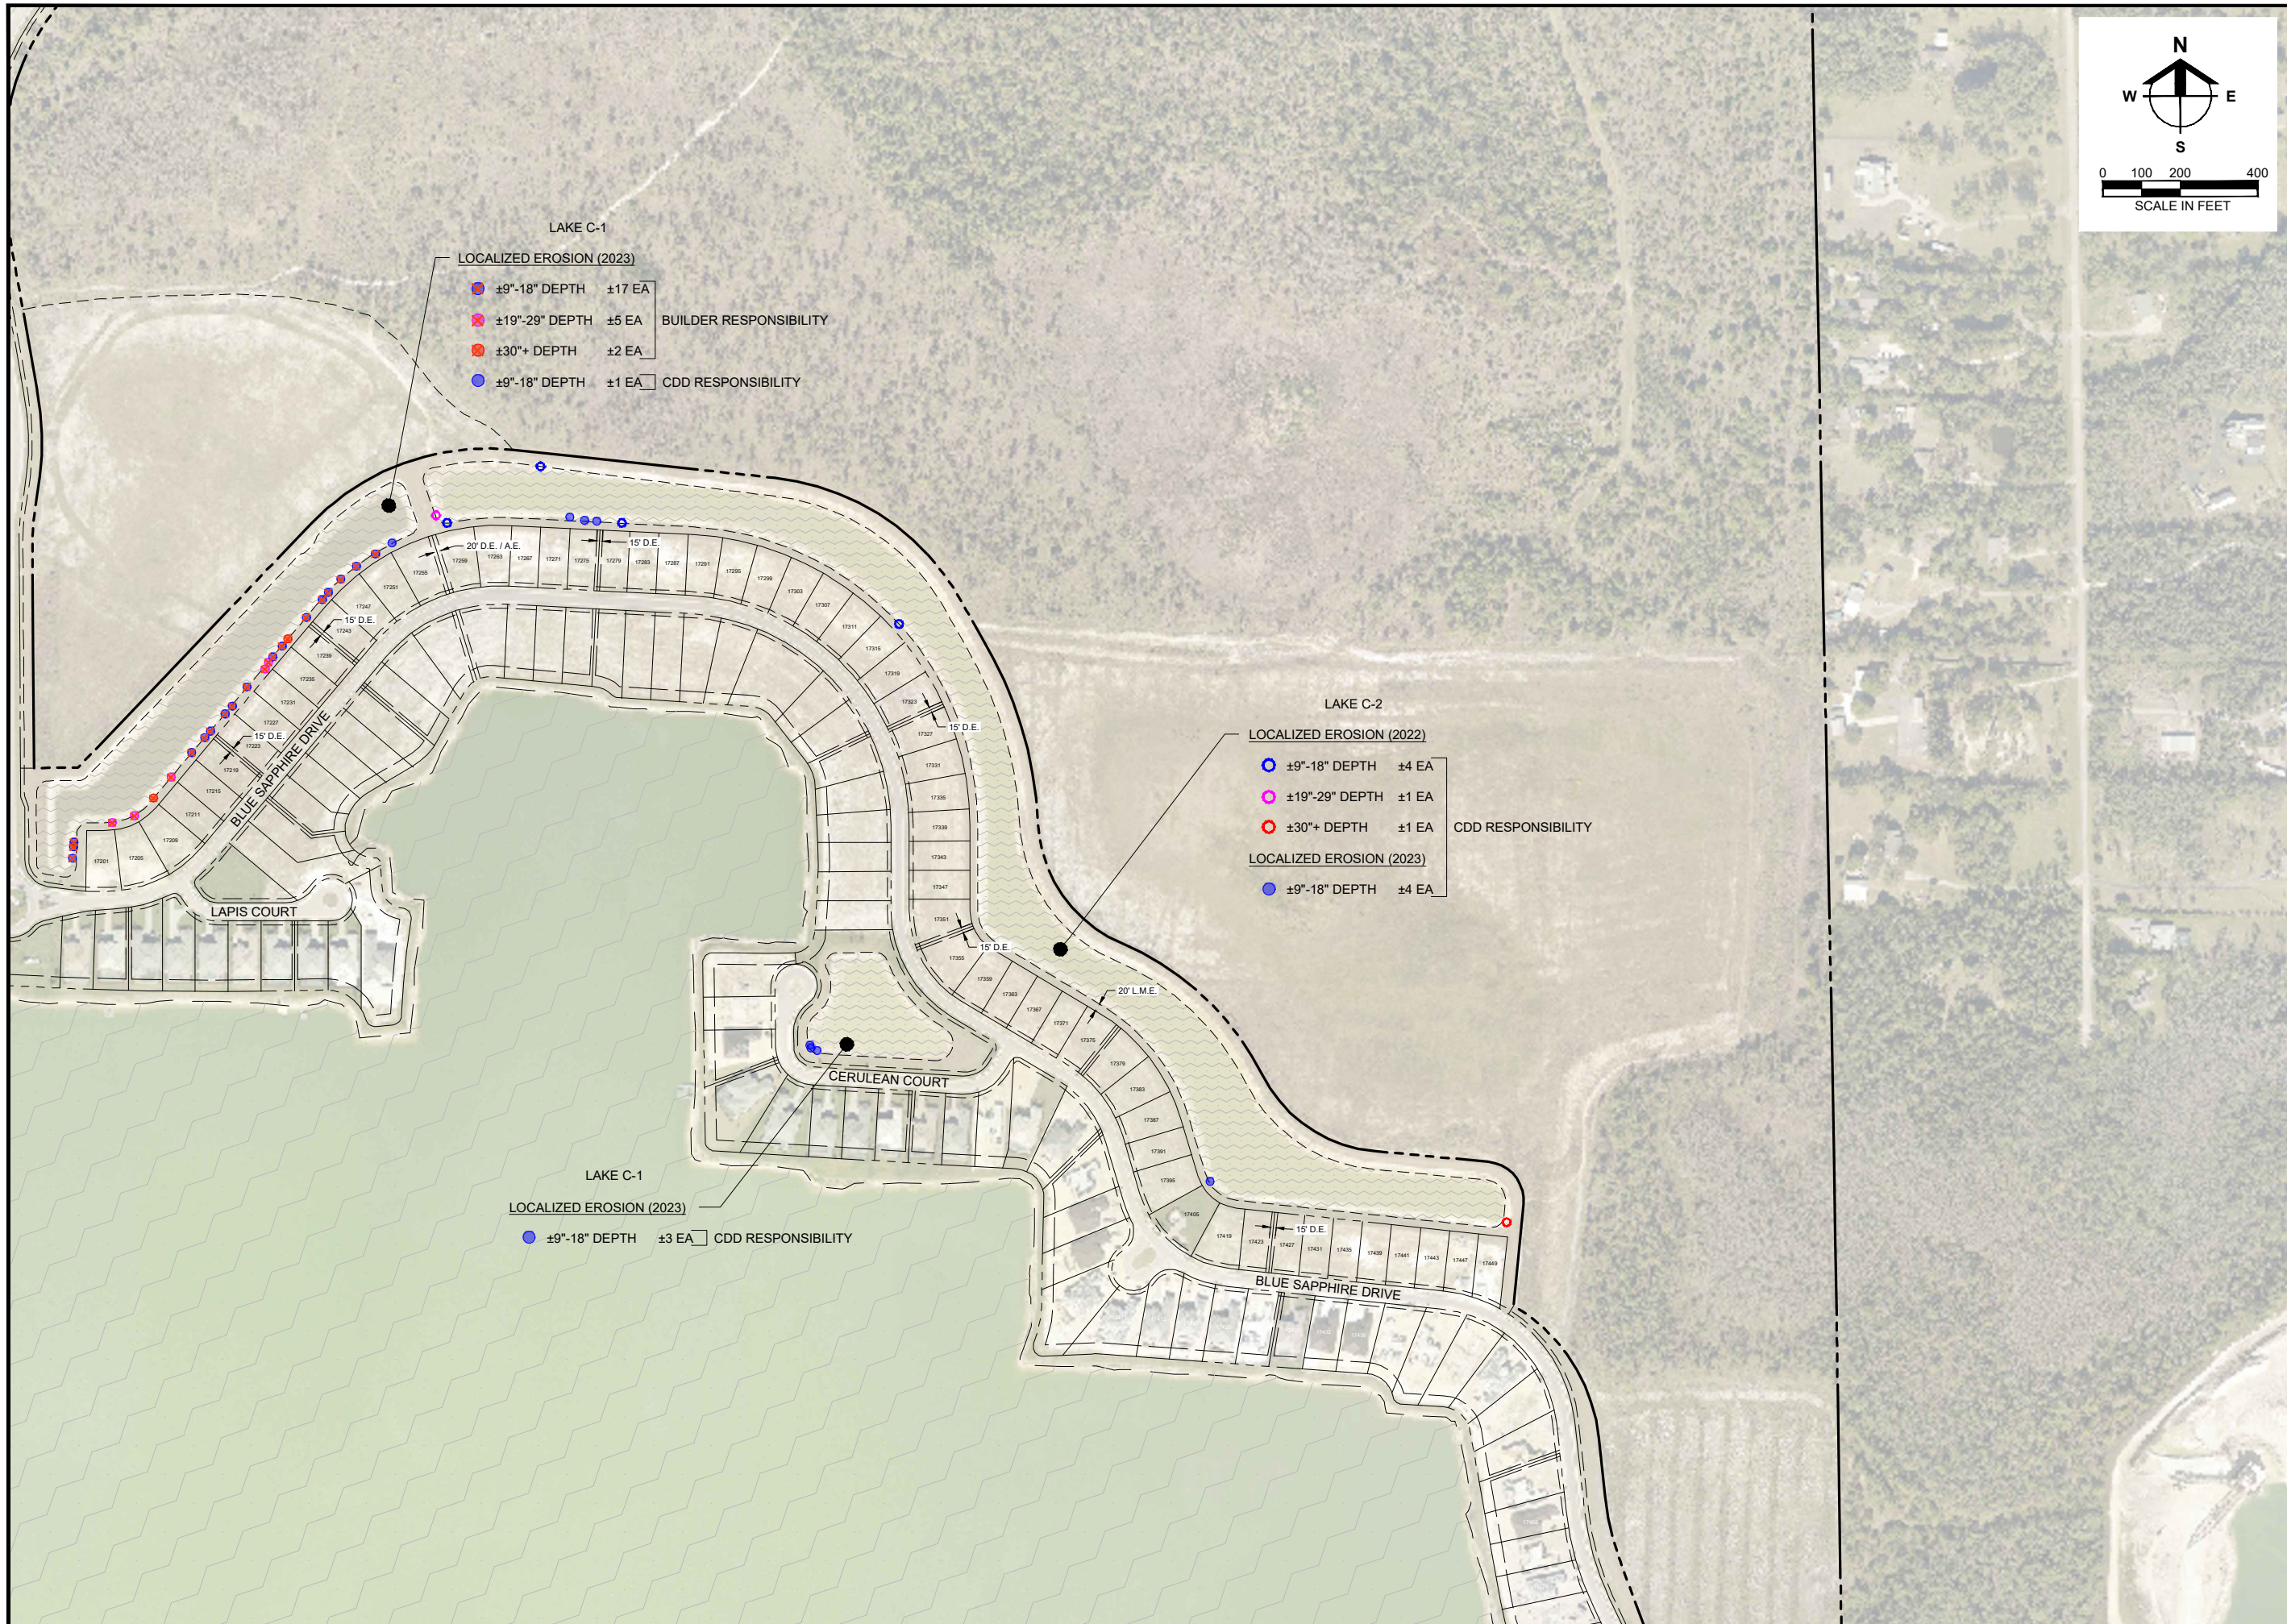
PROJECT / FILE NO.	SHEET NUMBER
23620	2.0

- LAKE C-1
- LOCALIZED EROSION (2023)**
- ±9"-18" DEPTH ±17 EA BUILDER RESPONSIBILITY
 - ±19"-29" DEPTH ±5 EA BUILDER RESPONSIBILITY
 - ±30"+ DEPTH ±2 EA BUILDER RESPONSIBILITY
 - ±9"-18" DEPTH ±1 EA CDD RESPONSIBILITY

- LAKE C-2
- LOCALIZED EROSION (2022)**
- ±9"-18" DEPTH ±4 EA CDD RESPONSIBILITY
 - ±19"-29" DEPTH ±1 EA CDD RESPONSIBILITY
 - ±30"+ DEPTH ±1 EA CDD RESPONSIBILITY
- LOCALIZED EROSION (2023)**
- ±9"-18" DEPTH ±4 EA CDD RESPONSIBILITY

- LAKE C-1
- LOCALIZED EROSION (2023)**
- ±9"-18" DEPTH ±3 EA CDD RESPONSIBILITY

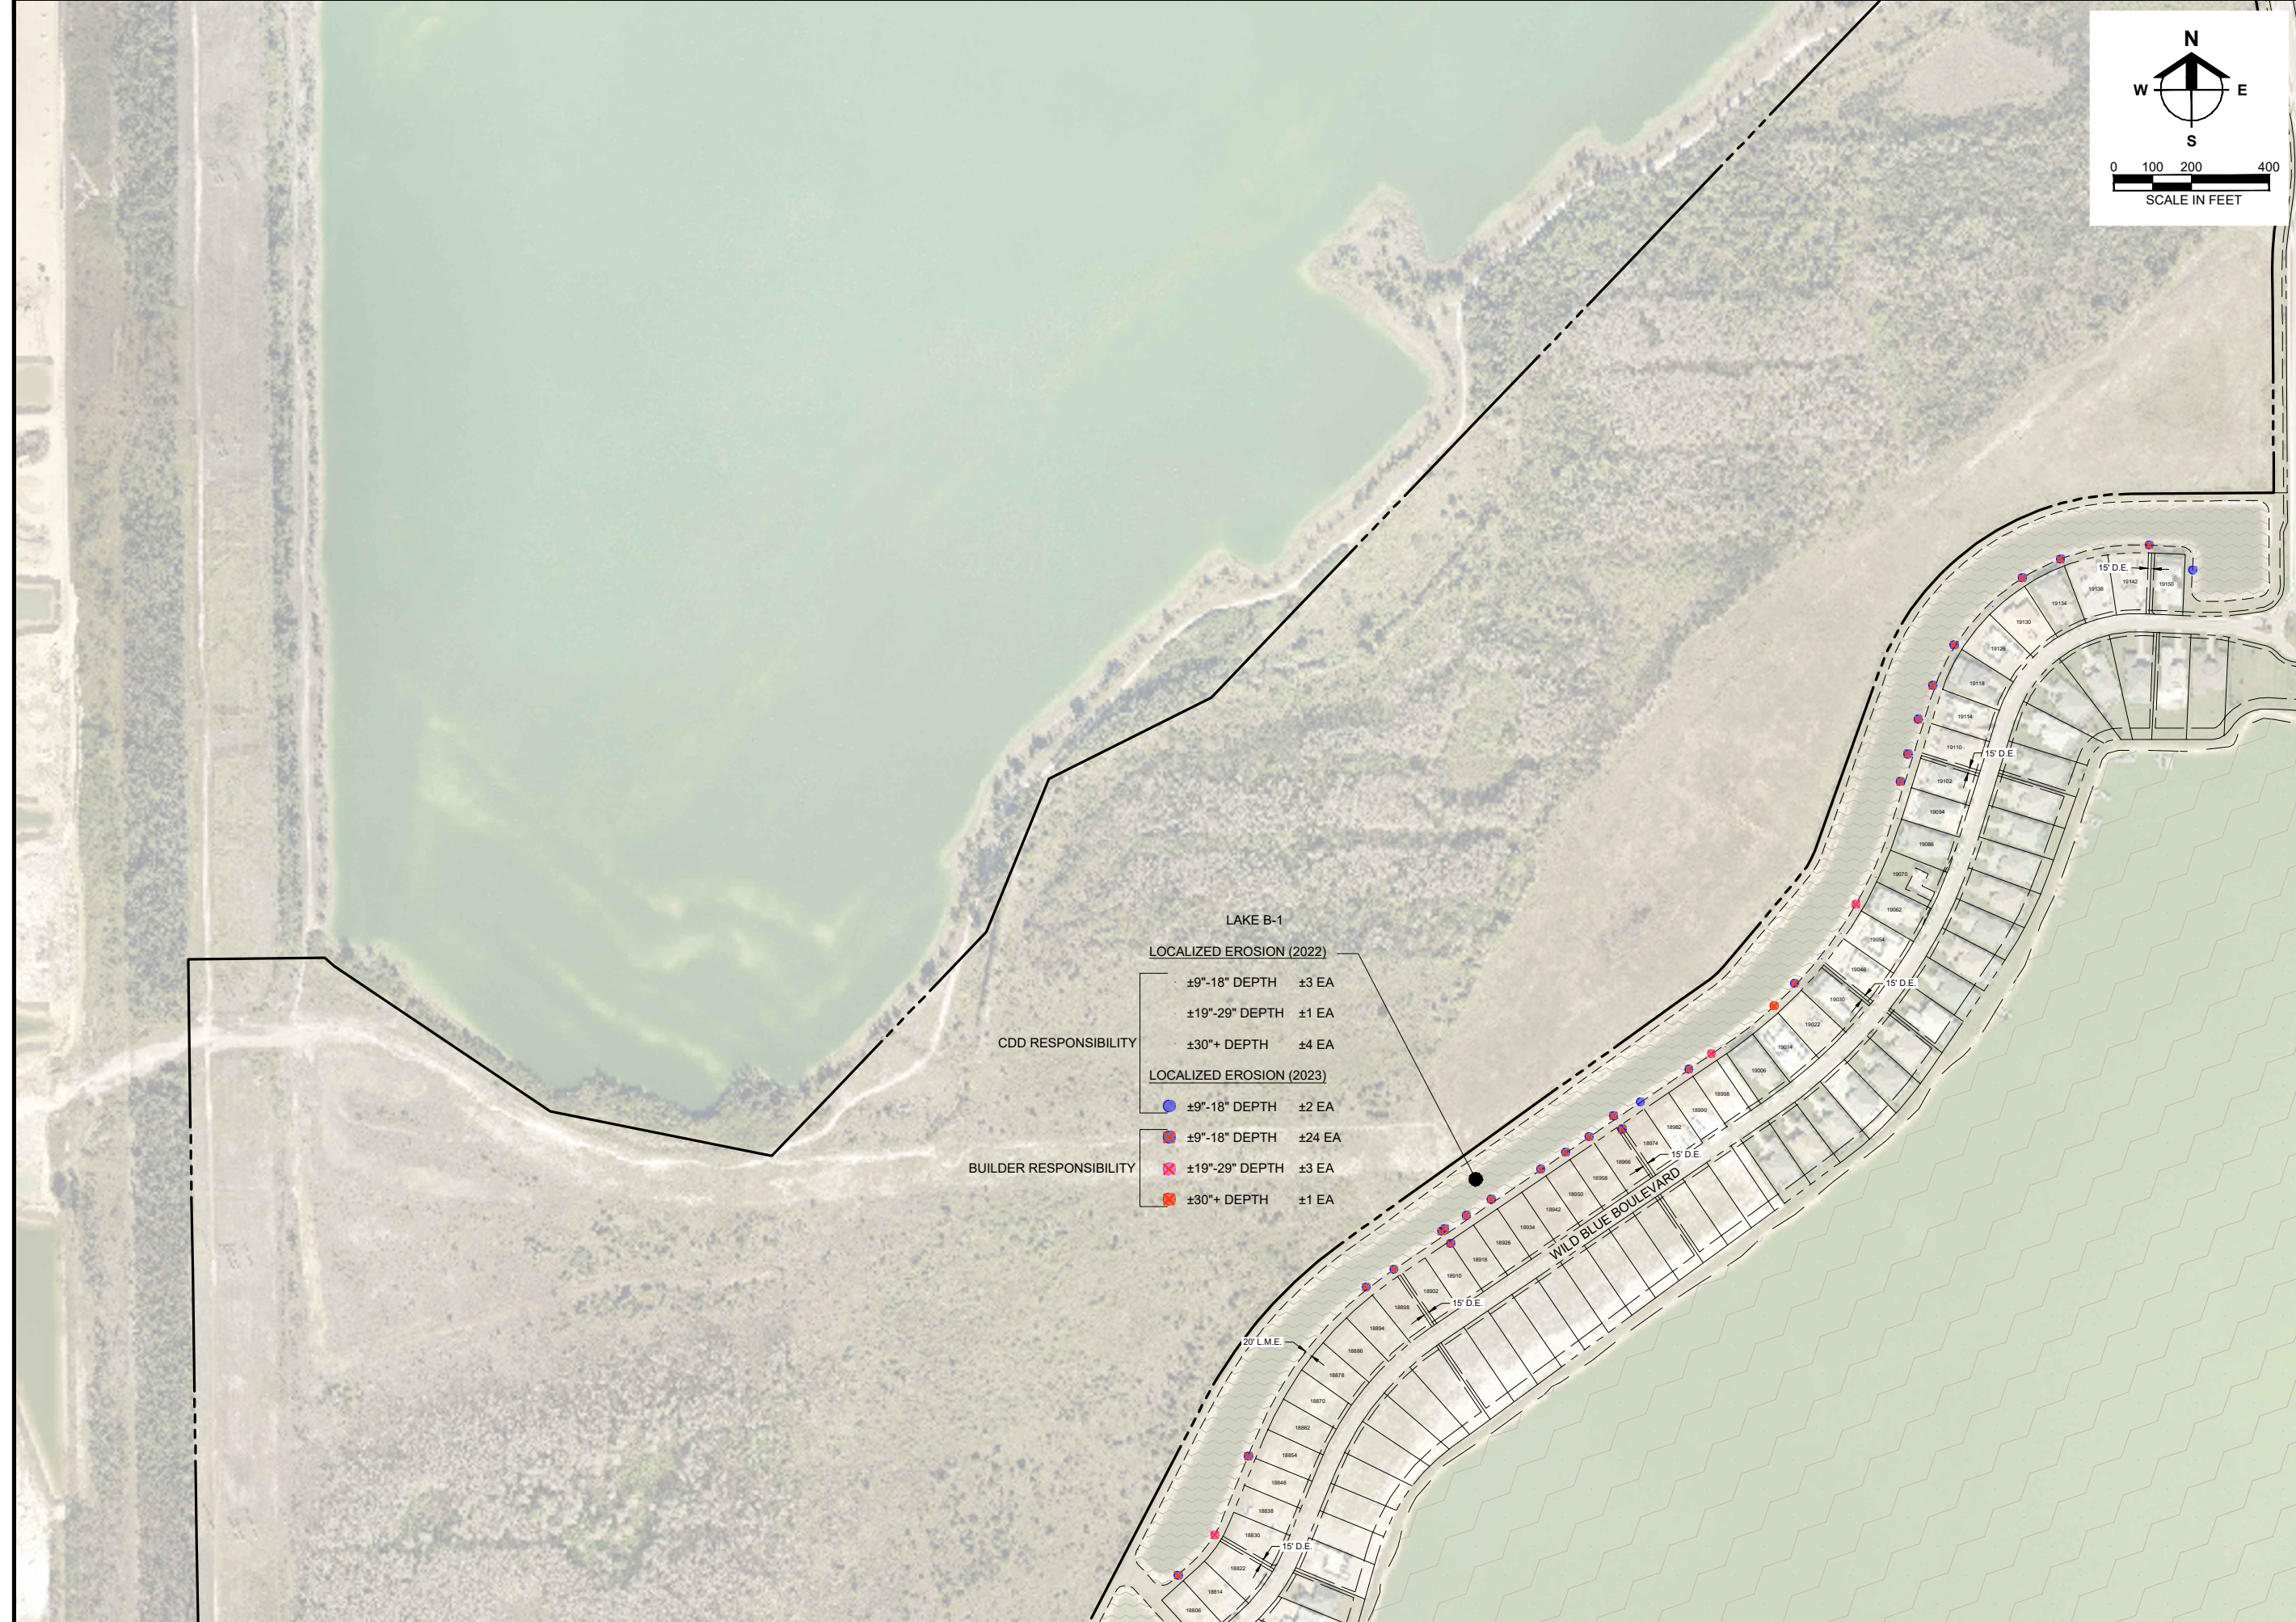
PROJECT / FILE NO.	SHEET NUMBER
23620	2.1

- LAKE B-1
- LOCALIZED EROSION (2022)**
- ±9"-18" DEPTH ±3 EA
 - ±19"-29" DEPTH ±1 EA
 - ±30"+ DEPTH ±4 EA
- LOCALIZED EROSION (2023)**
- ±9"-18" DEPTH ±2 EA
 - ±9"-18" DEPTH ±24 EA
 - ±19"-29" DEPTH ±3 EA
 - ±30"+ DEPTH ±1 EA

CDD RESPONSIBILITY

BUILDER RESPONSIBILITY

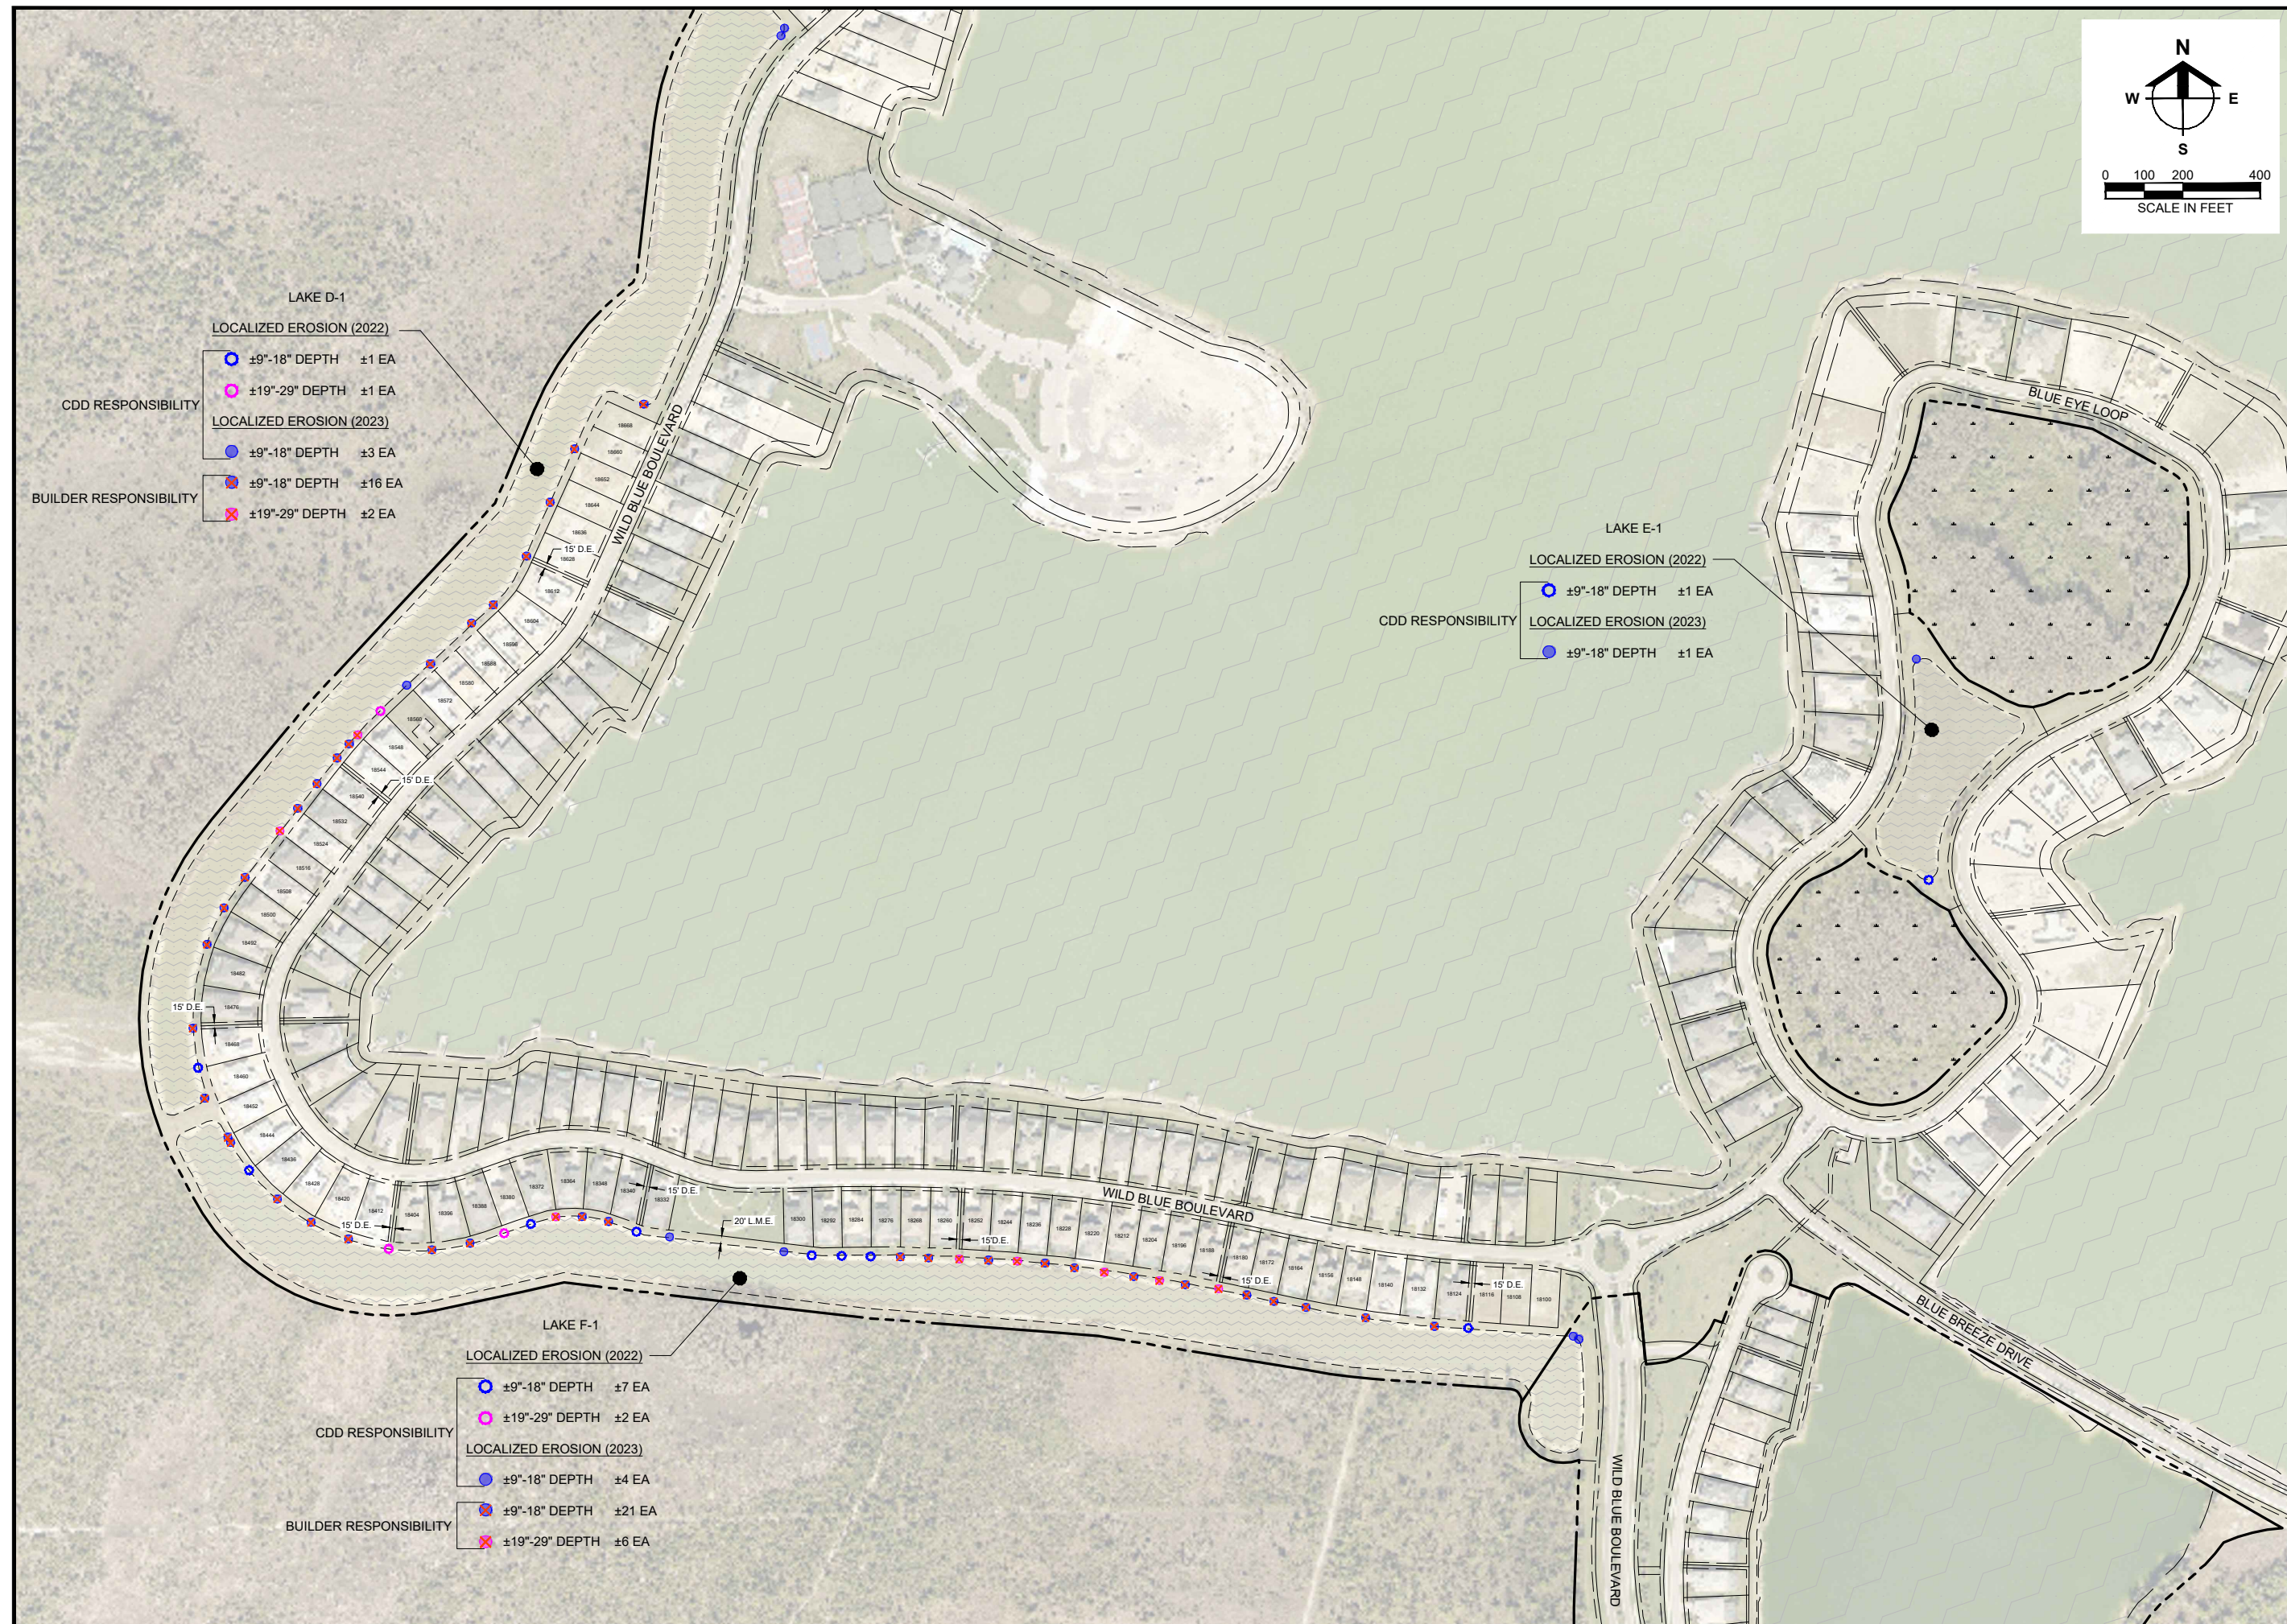
PROJECT / FILE NO. **23620** SHEET NUMBER **2.2**

- LAKE D-1**
- LOCALIZED EROSION (2022)**
- ±9"-18" DEPTH ±1 EA
 - ±19"-29" DEPTH ±1 EA
- LOCALIZED EROSION (2023)**
- ±9"-18" DEPTH ±3 EA
 - ⊗ ±9"-18" DEPTH ±16 EA
 - ⊗ ±19"-29" DEPTH ±2 EA
- CDD RESPONSIBILITY**
- BUILDER RESPONSIBILITY**

- LAKE E-1**
- LOCALIZED EROSION (2022)**
- ±9"-18" DEPTH ±1 EA
- LOCALIZED EROSION (2023)**
- ±9"-18" DEPTH ±1 EA
- CDD RESPONSIBILITY**

- LAKE F-1**
- LOCALIZED EROSION (2022)**
- ±9"-18" DEPTH ±7 EA
 - ±19"-29" DEPTH ±2 EA
- LOCALIZED EROSION (2023)**
- ±9"-18" DEPTH ±4 EA
 - ⊗ ±9"-18" DEPTH ±21 EA
 - ⊗ ±19"-29" DEPTH ±6 EA
- CDD RESPONSIBILITY**
- BUILDER RESPONSIBILITY**

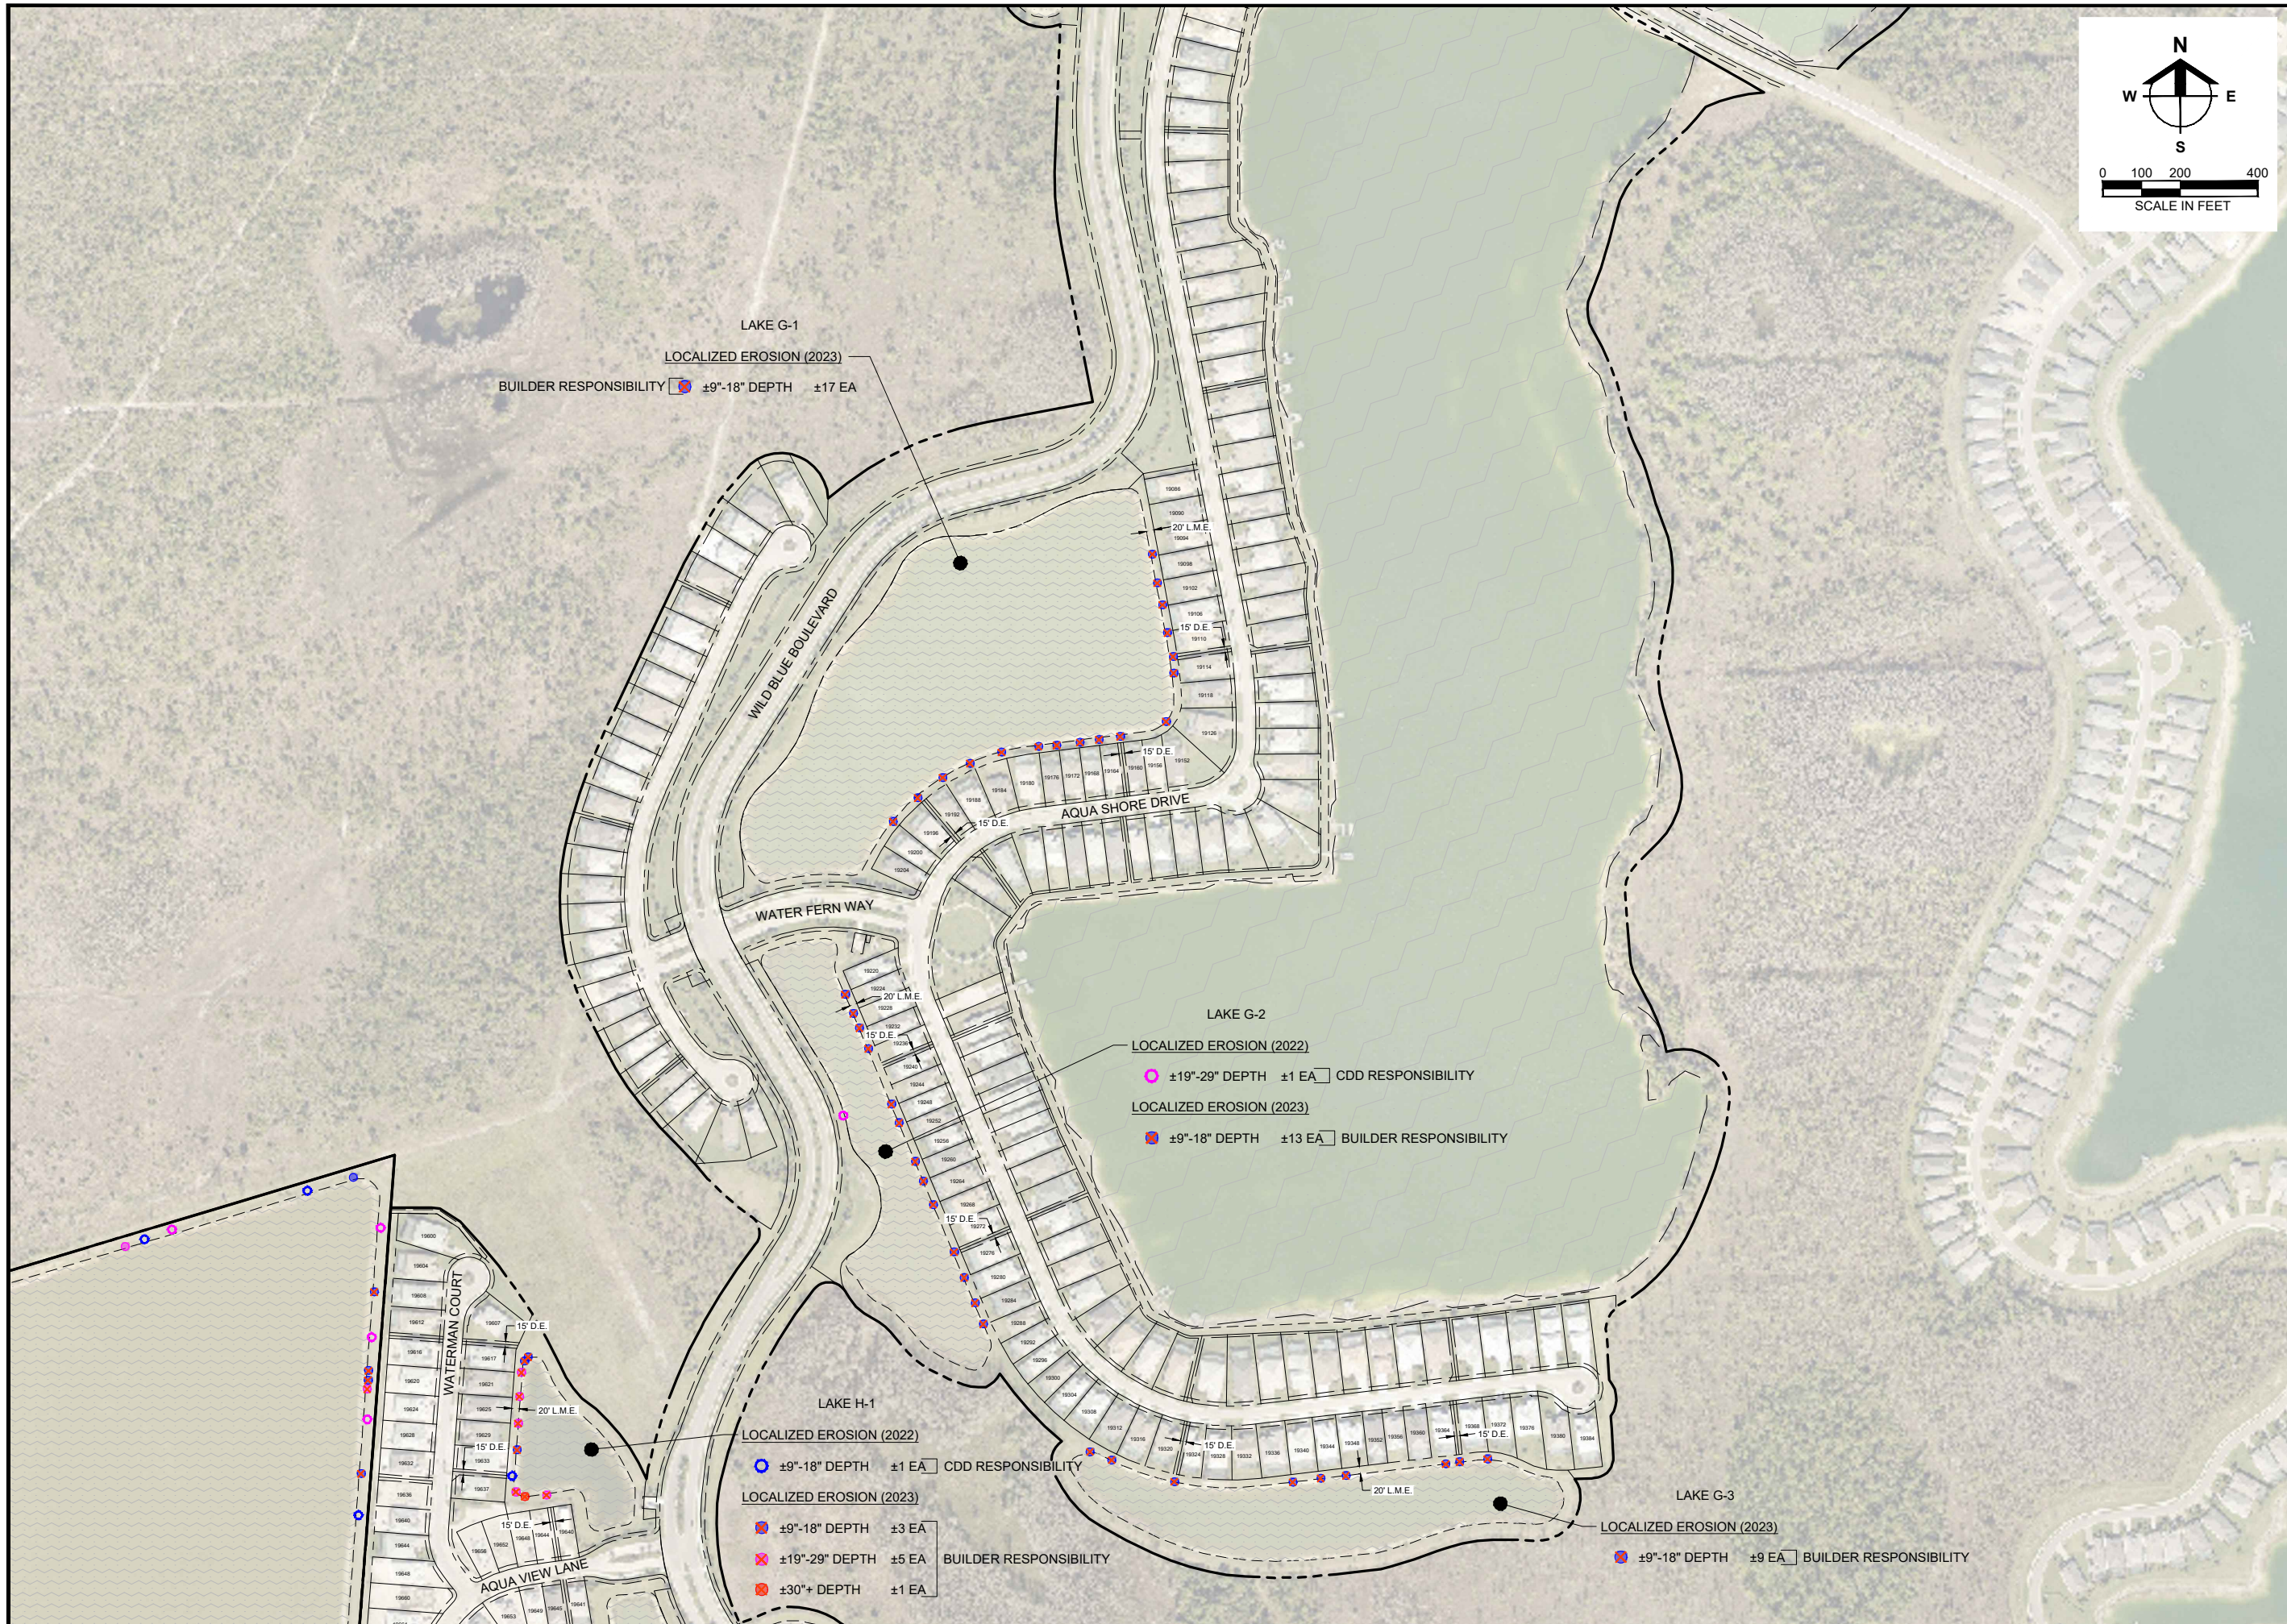
PROJECT / FILE NO.	SHEET NUMBER
23620	2.3

LAKE G-1
LOCALIZED EROSION (2023)
BUILDER RESPONSIBILITY ±9"-18" DEPTH ±17 EA

LAKE G-2
LOCALIZED EROSION (2022)
±19"-29" DEPTH ±1 EA CDD RESPONSIBILITY
LOCALIZED EROSION (2023)
±9"-18" DEPTH ±13 EA BUILDER RESPONSIBILITY

LAKE H-1
LOCALIZED EROSION (2022)
±9"-18" DEPTH ±1 EA CDD RESPONSIBILITY
LOCALIZED EROSION (2023)
±9"-18" DEPTH ±3 EA
±19"-29" DEPTH ±5 EA BUILDER RESPONSIBILITY
±30"+ DEPTH ±1 EA

LAKE G-3
LOCALIZED EROSION (2023)
±9"-18" DEPTH ±9 EA BUILDER RESPONSIBILITY
