WILD BLUE LAKE RESTORATION PROJECT

**WILDBLUE
COMMUNITY
DEVELOPMENT
DISTRICT**

**MASTER PLAN WITH
KEY SHEET AND
ESTIMATED TIMELINE**

**DETAILED
LAKE BANK
RESTORATION PLAN**

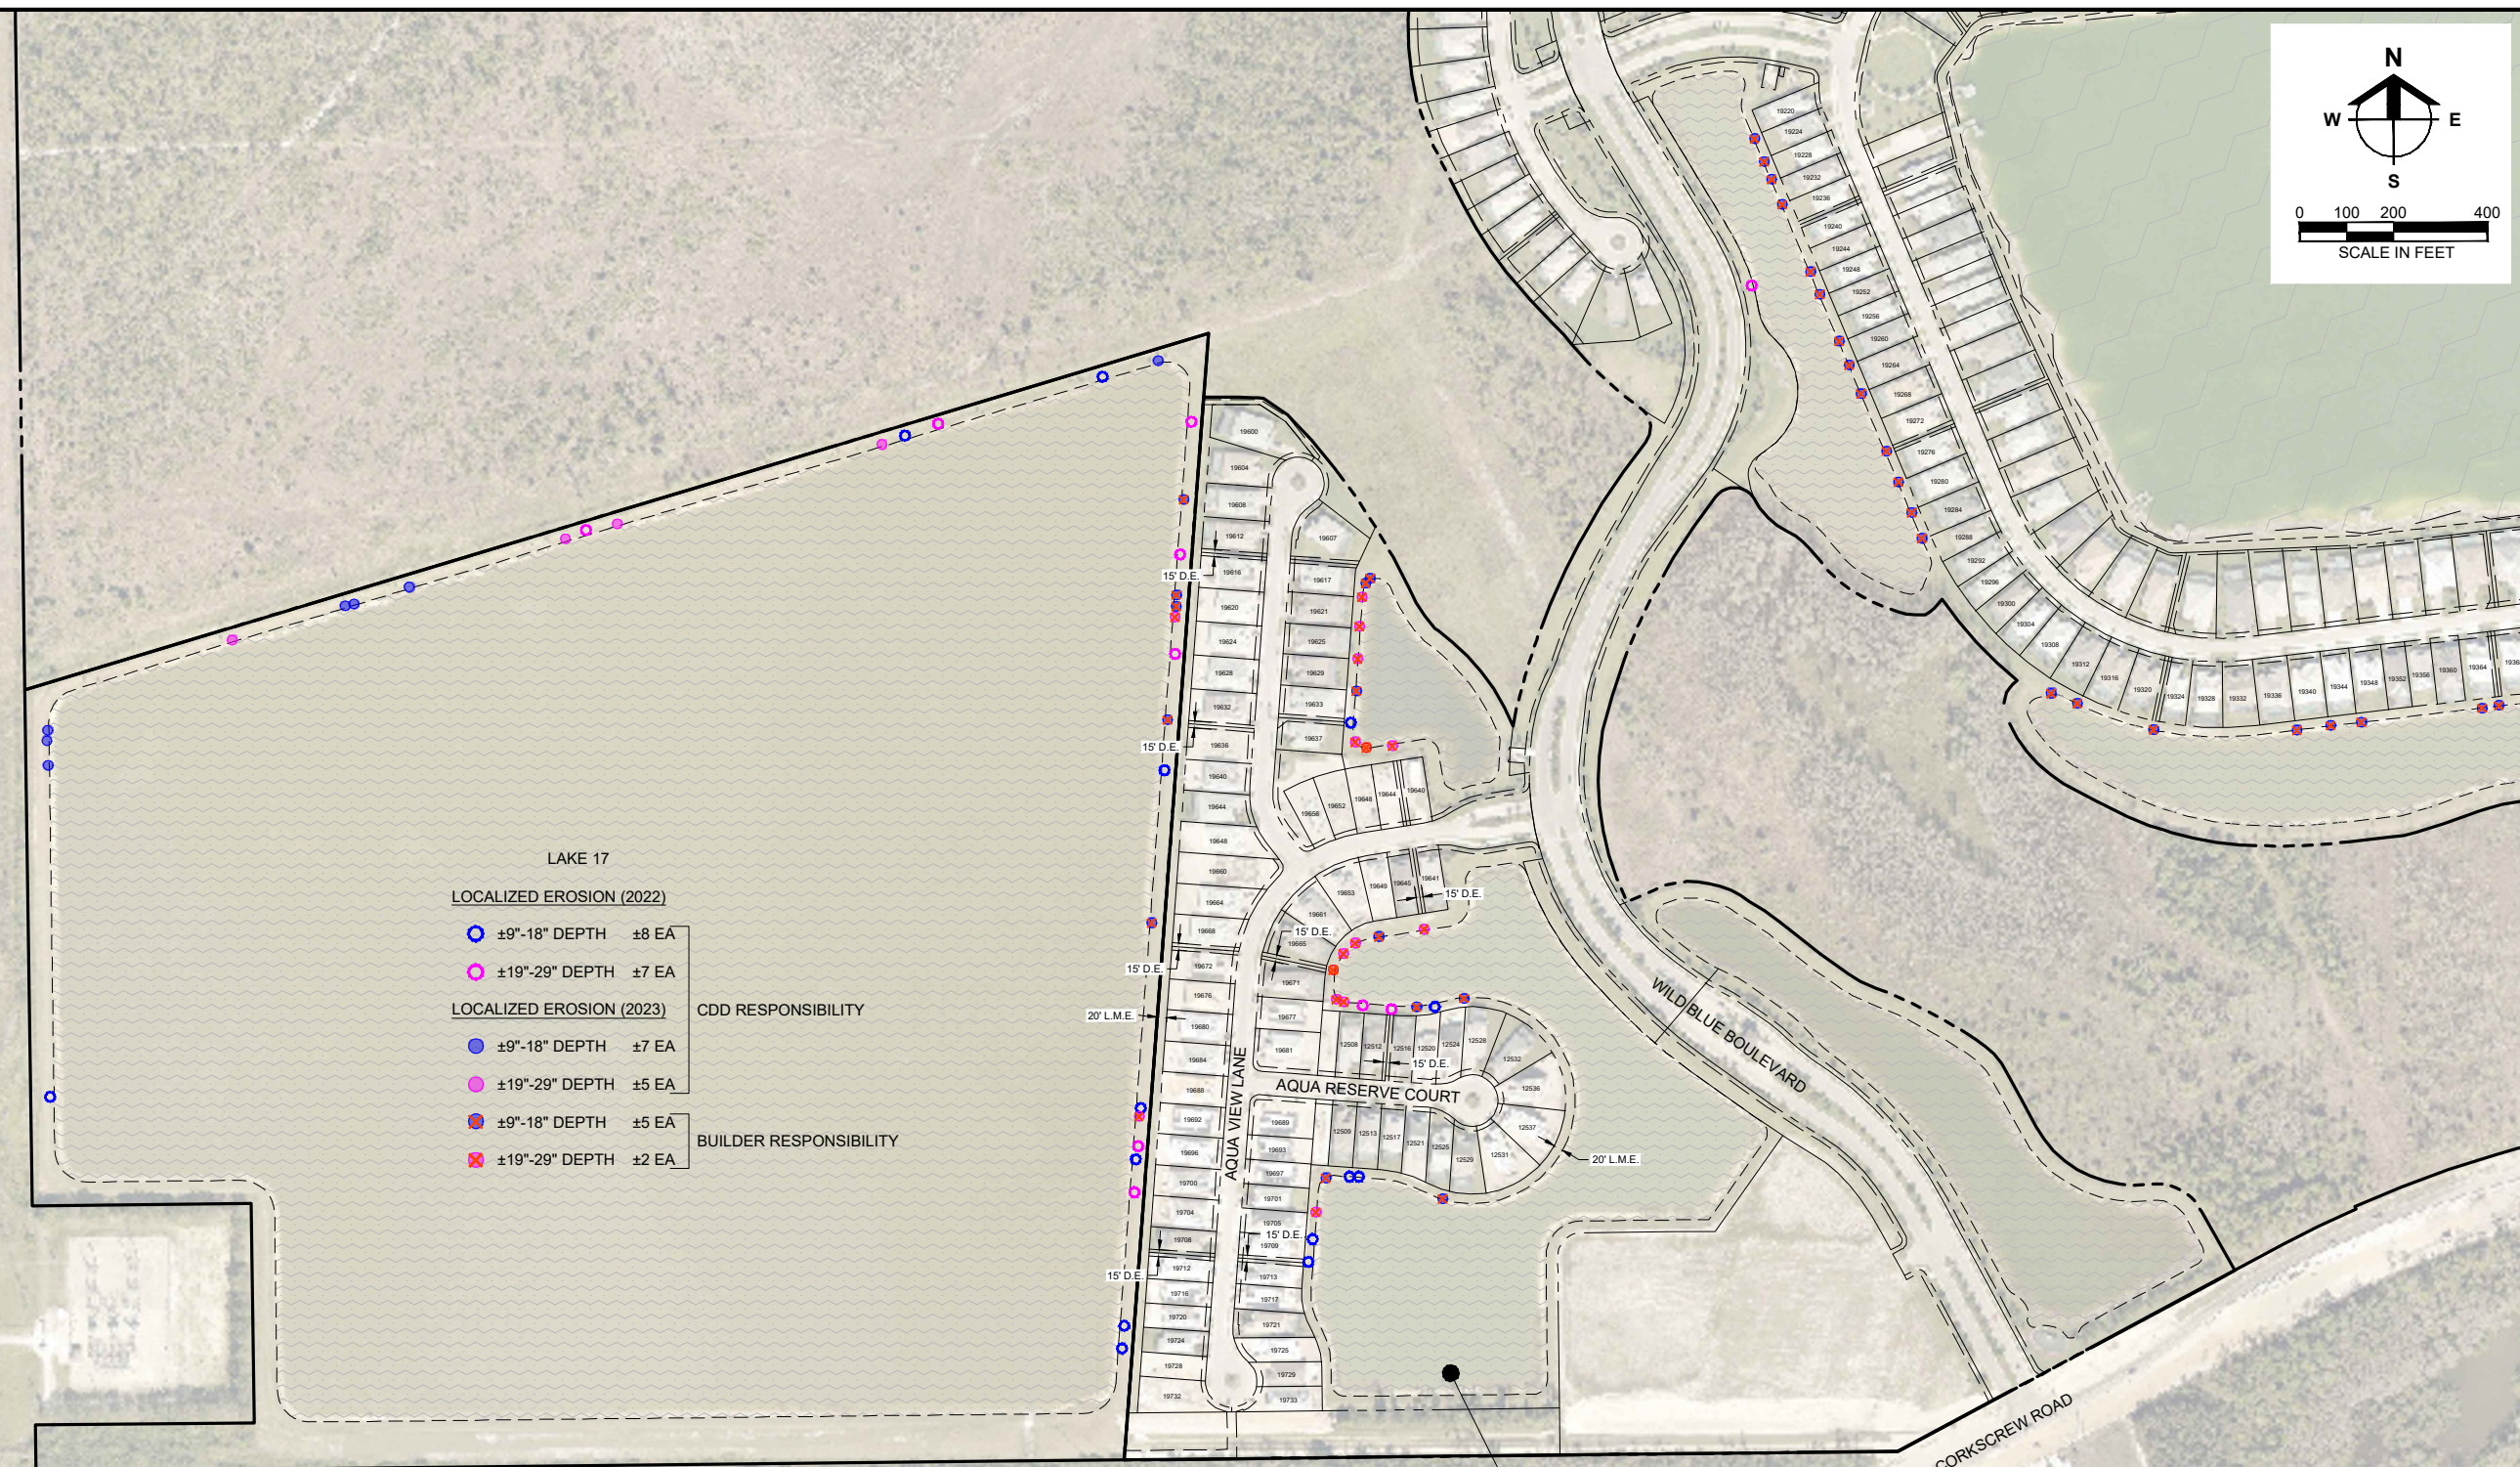
PROJECT / FILE NO. **23620** SHEET NUMBER **2.4**

- LAKE 17**
- LOCALIZED EROSION (2022)**
- ±9"-18" DEPTH ±8 EA
 - ±19"-29" DEPTH ±7 EA
- LOCALIZED EROSION (2023)** CDD RESPONSIBILITY
- ±9"-18" DEPTH ±7 EA
 - ±19"-29" DEPTH ±5 EA
- BUILDER RESPONSIBILITY**
- ⊗ ±9"-18" DEPTH ±5 EA
 - ⊗ ±19"-29" DEPTH ±2 EA

- LAKE C-1**
- LOCALIZED EROSION (2022)**
- ±9"-18" DEPTH ±5 EA
 - ±19"-29" DEPTH ±2 EA
- LOCALIZED EROSION (2023)** CDD RESPONSIBILITY
- ±9"-18" DEPTH ±5 EA
 - ⊗ ±19"-29" DEPTH ±6 EA
 - ⊗ ±30"+ DEPTH ±1 EA
- BUILDER RESPONSIBILITY**
